# BioSA: Bridging the gap with biodegradable metals

1 July 2019

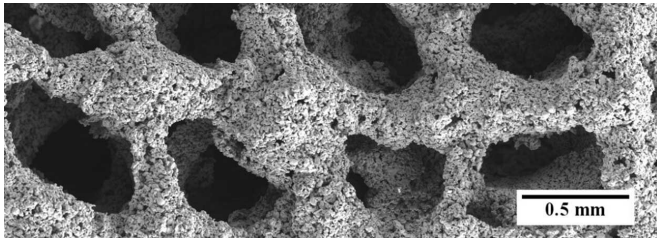
Scanning Electron Microscopy image of the first BioSA prototype. Credit: University of Malta

The BioSA team is focused on understanding the corrosion behaviour of such an implant while also studying the effect that such an implant has on cells found in the [bone](#). Through an innovative processing technique, based on the use of metal powders, the team also aims to gain control over the shape of the final [scaffold](#). Accidents can happen to everyone and defects can be bigger than the body can heal naturally. So ideally scaffolds are not designed as one-size-fits-all but can also be custom-made for a specific patient.
